Manhole Inspection Summary

Manhole # S43GG_025MH

Insp Date: 1/11/08 11:38 AM

Location Address: **N BOND ST**

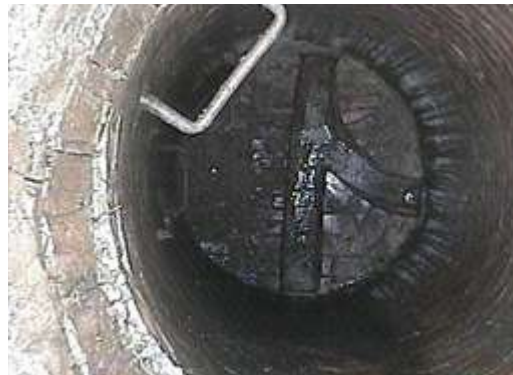
Defect 4

Count: **5** Missing: **3** ☒ **Corroded**

STEPS CORRODED

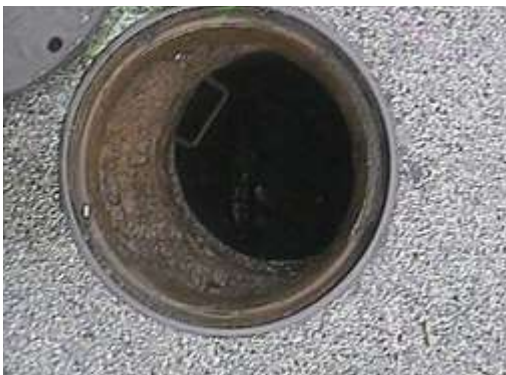
Defect 3

Offset: **5** (in.)

FRAME OFFSET

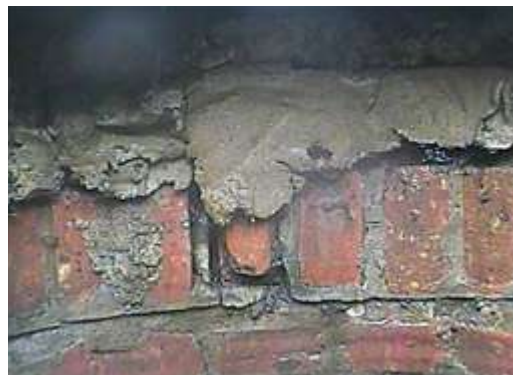
Defect 1

Condition: ☐ Sound ☒ **Cracked** ☐ Root Intrusion ☐ Loose Brick ☐ Deteriorated

FRAME ADJUSTMENT CRACKED AND
SOURCE OF SMALL AMOUNTS OF I/I.

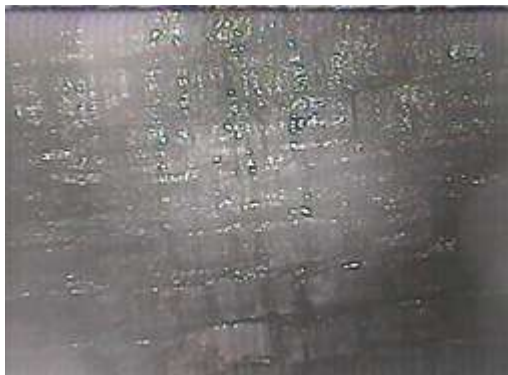
Defect 2

Infiltration: ☐ None ☒ **Joint** ☐ Cracks ☐ Mortar ☐ Roots ☒ **Wall**

SIGNS OF BARREL RUST ON MH WALL

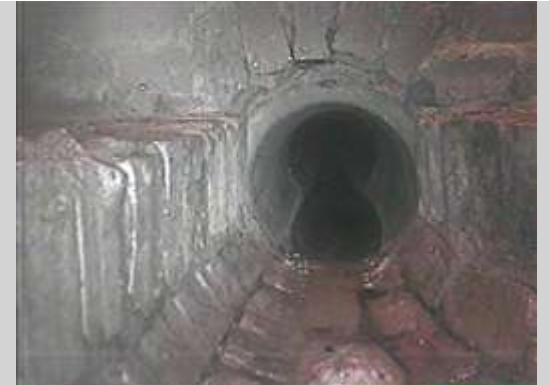
12 O'Clock Outflow

Pipe Height: (in.) Direct
Pipe Material: **Clay** ☐ Pipe Lined
Invert Depth: **10.04** (ft.) Flow Characteristics: **Slow**
Deposits: ☒ None ☐ Mud ☐ Sludge ☐ Debris ☐ Grease
Silt Depth: (in.) Deposits Extent:
Infiltration: **None** Pipe Seal Cond: **Sound**

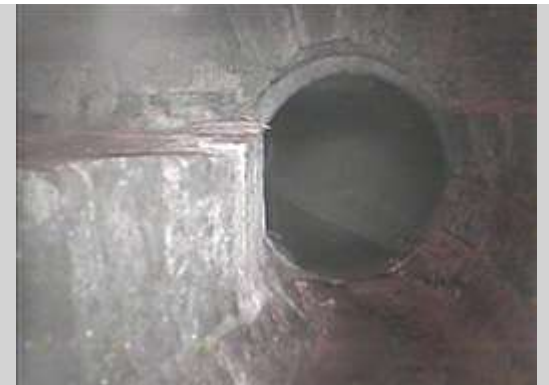
3 O'Clock Inflow

Pipe Height: (in.) Direct
Pipe Material: **Clay** ☐ Pipe Lined
Invert Depth: **10.02** (ft.) Flow Characteristics: **Slow**
Deposits: ☒ None ☐ Mud ☐ Sludge ☐ Debris ☐ Grease
Silt Depth: (in.) Deposits Extent:
Infiltration: **None** Pipe Seal Cond: **Sound**

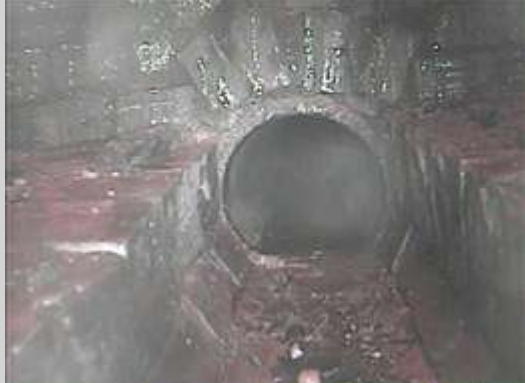
6 O'Clock Inflow

Infiltration: **None** Pipe Seal Cond: **Sound**
